COMPOSITE FAILURE ANALYSIS HANDBOOK  
VOL I - PROGRAM OVERVIEW

R.J. Kar  
Northrop Corporation  
One Northrop Avenue  
Hawthorne, California 90250-3277

February 1992

Final Report for Period January 1987 - October 1990

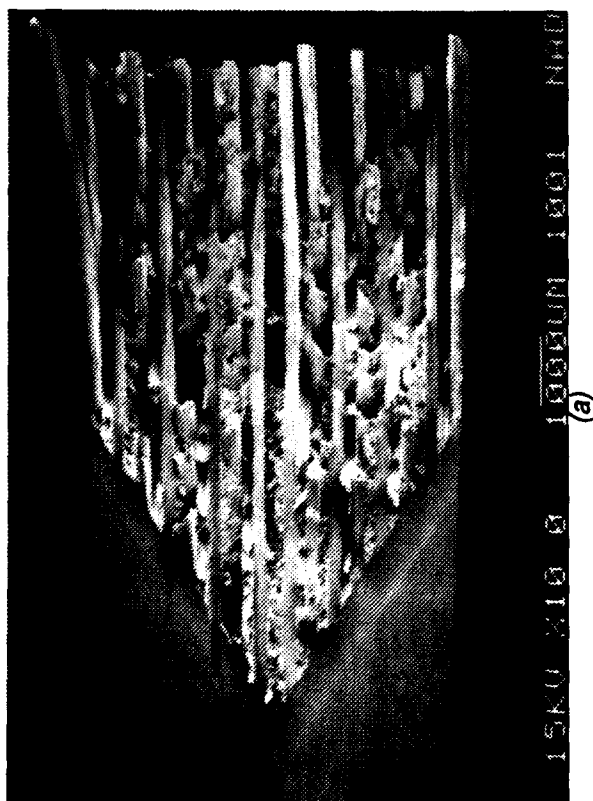
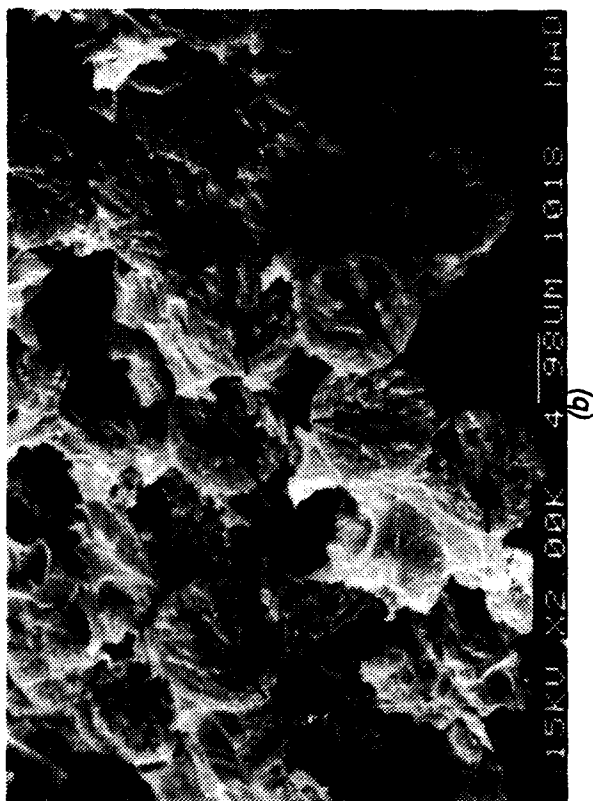
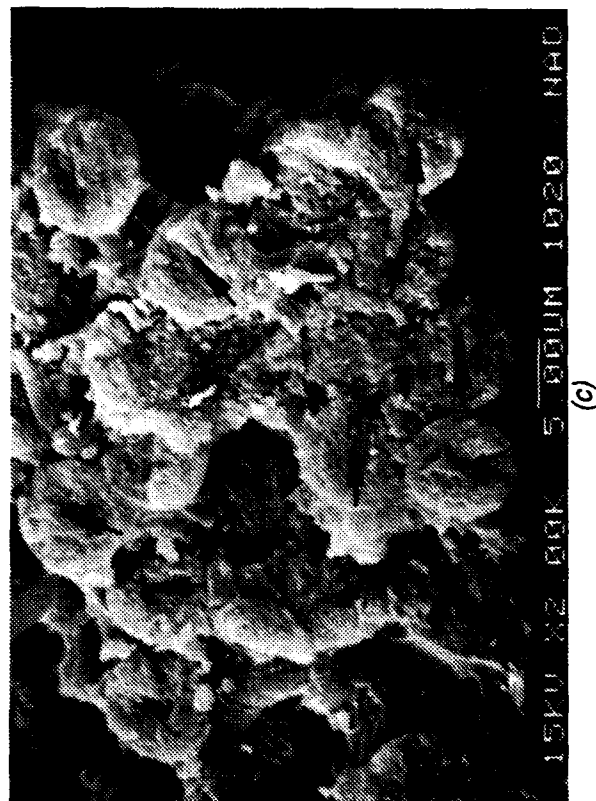
**Figure 3-26. SEM Photographs of Mode I Translaminar Tension Fracture in High Resin Content Gr/Ep - 32 Ply Quasi-Isotropic**

**(a) Macro photograph of the Fracture and Apex**

**(b) Fracture Near the Apex**

**Note:** Radial lines on fractured fiber ends indicate local fracture path (shown by arrows).

**(c) Fracture Features Present in Ply Oriented Normal to Fracture and in the Center of the Test Specimen**

**Note:** Fracture path indicated by arrows.

**Mode I Tension High Resin Content Gr/Ep - 32/Quasi.** Figure 3-26 presents photographs illustrating macroscopic and microscopic translaminar tension fracture features observed in 32 ply/quasi-isotropic Gr/Ep that was processed with a high resin content.

Figure 3-26a shows the fracture surface and the apex of the notch machined to initiate crack-propagation under translaminar Mode I tension. Translaminar tension fracture was characterized by fiber end fracture, fiber pullout, and matrix fracture.

Evaluation of the fractured fiber ends in plies oriented normal to the direction of macroscopic fracture revealed the occurrence of radial lines that fanned outward and away from local fracture origins. These indicators could be used to map the overall direction of crack-propagation (Figures 3-26b and 3-26c) in individual fiber bundles. The radial lines were believed to be 'DAF radials' (DAF = directly attributable failure) reported by Dr. Purslow that form during translaminar fracture.

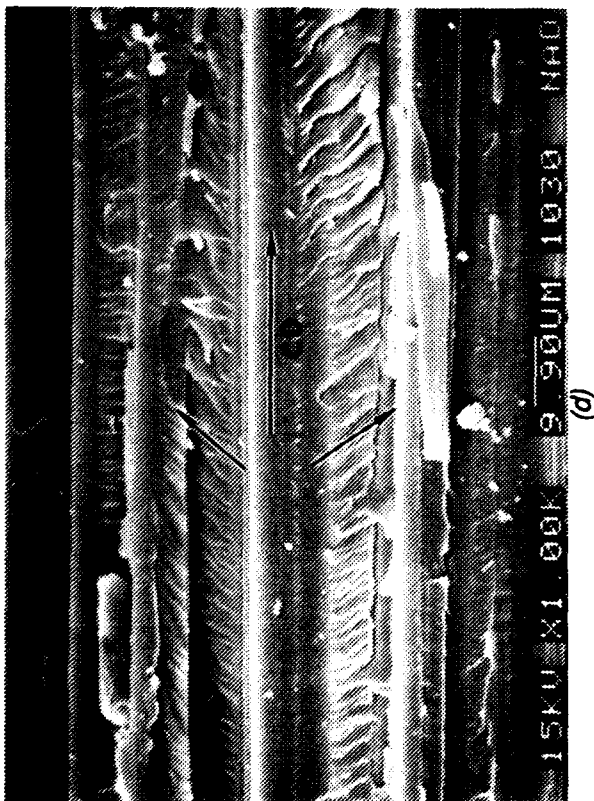
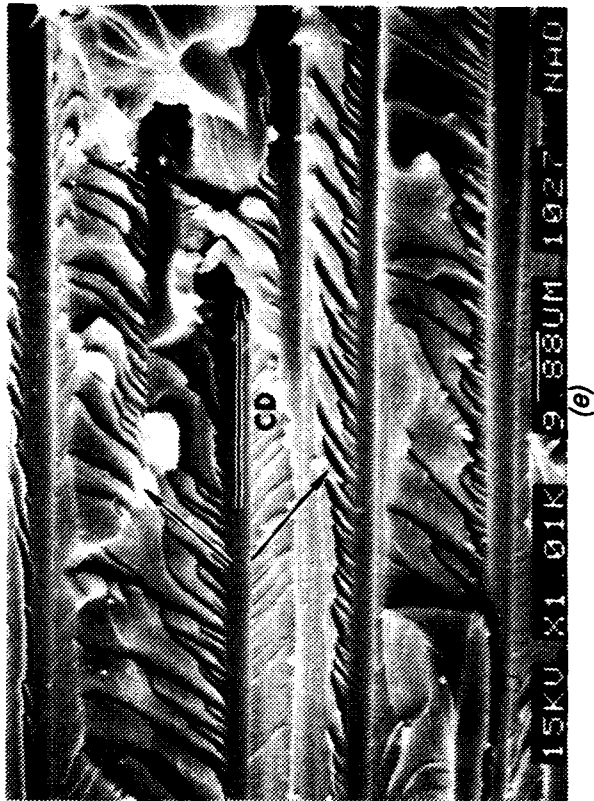
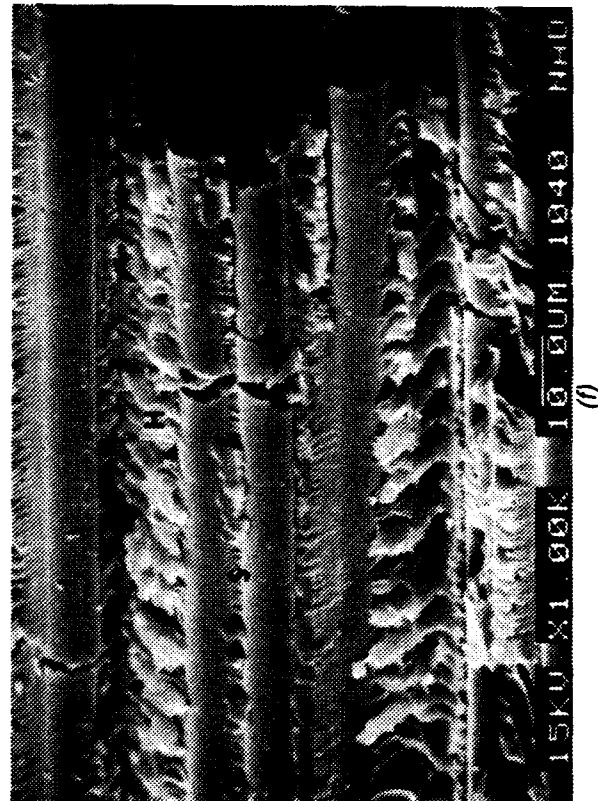
Figure 3-26. (Continued)  
(d), (e) River Patterns (Arrows) Present in the  
Fractured Epoxy Regions of a 90 Degree Ply  
(f) Hackles (H), Scallops (S) and Broken Fibers  
in a 45 Degree Ply

river patterns, hackles, and scallops (Figure 3-26d, e, and f), similar to those previously observed in interlaminar failures. Plies oriented parallel to the macroscopic crack growth direction exhibited more pronounced river pattern formation that coalesced and pointed in the direction of crack-growth. The plies oriented at 45 degrees to the macroscopic crack growth direction showed more pronounced scallop and hackle formation and broken fibers (Figure 3-26f). The river patterns could again be used to map the direction of crack-growth in these plies.

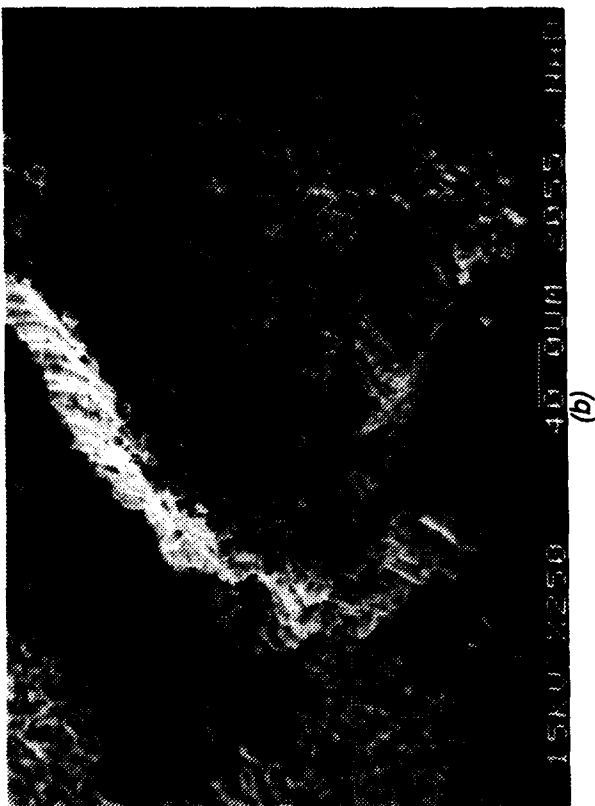
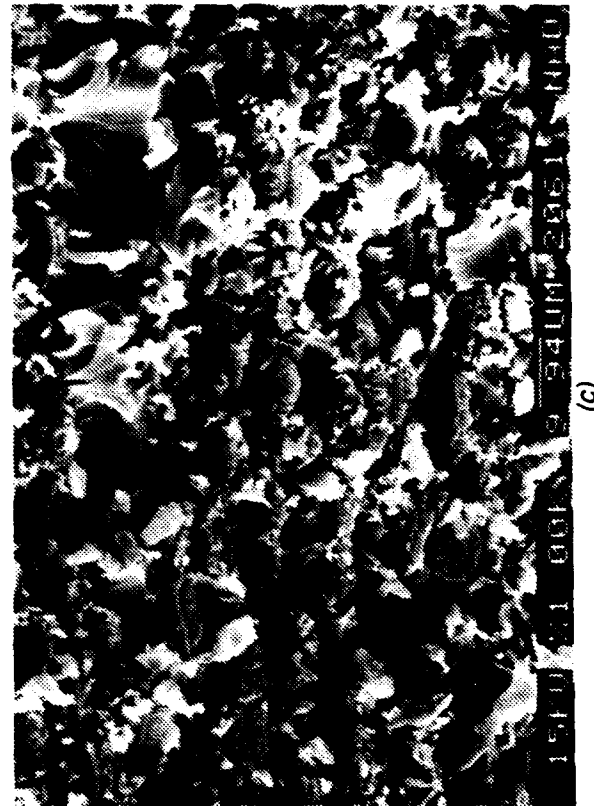
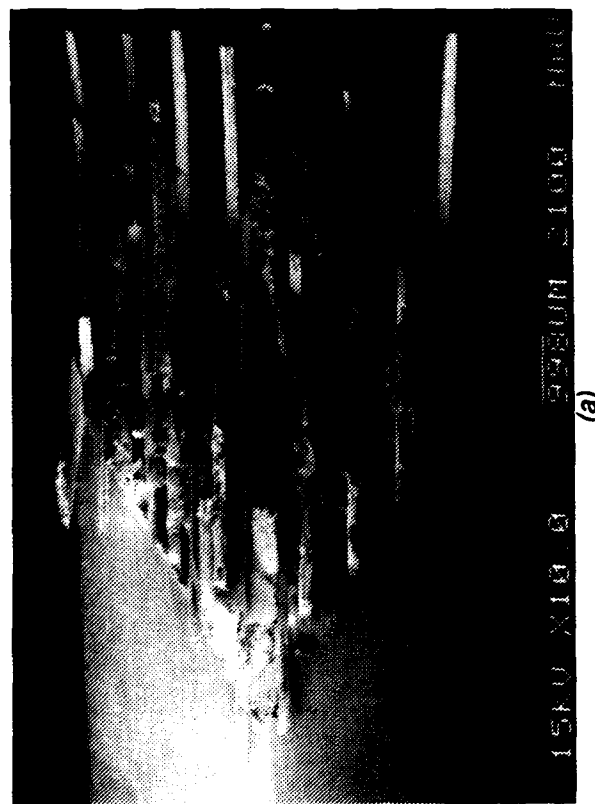
Figure 3-27. SEM Photographs of Mode I Translaminar Compression Fracture in High Resin Content Gr/Ep - 32 Ply Quasi-Isotropic  
 (a) Macro photograph of the Fracture and Apex  
 (b) Fracture Near the Apex  
 Note the flat fracture surface and the post fracture damage  
 (c) High Magnification of (b) Showing Crushed Fibers

**Mode I Compression High Resin Content Gr/Ep - 32/Quasi.** Figure 3-27 presents photographs illustrating macroscopic and microscopic translaminar compression fracture features in 32 ply/quasi-isotropic Gr/Ep processed with high resin content.

Figure 3-27a shows the fracture surface and the apex of the notch machined to initiate crack-propagation under translaminar Mode I compression. Translaminar compression fracture was typified by fiber buckling, fiber-end fracture, resin shear fracture, and post-fracture damage.

Evaluation of the fractured surface revealed a flat topography and post-fracture damage (Figures 3-27b and 3-27c). As shown in Figure 3-27d, flexural fracture was observed as a result of translaminar compression. Fractured fiber ends were decorated with "chop" marks that are typical of failure due to compression microbuckling. The crack-propagation direction could not be determined through observation of these fracture features.

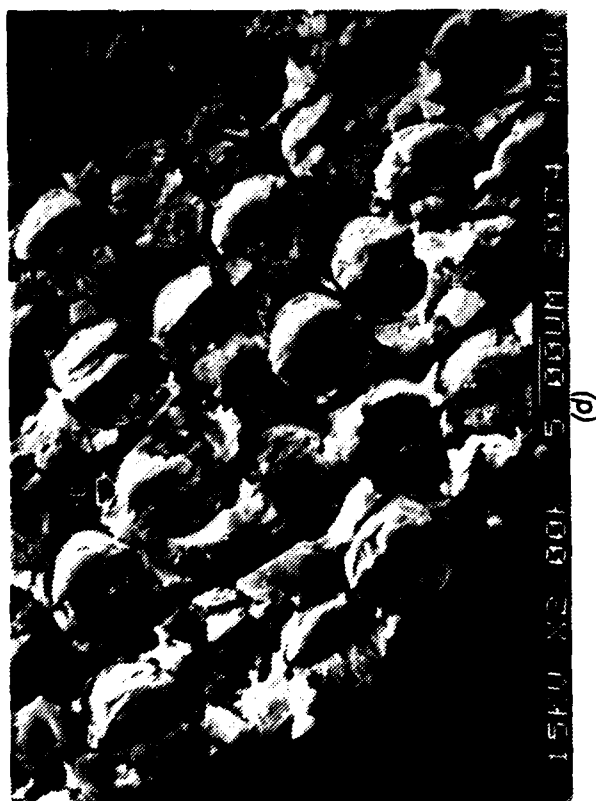
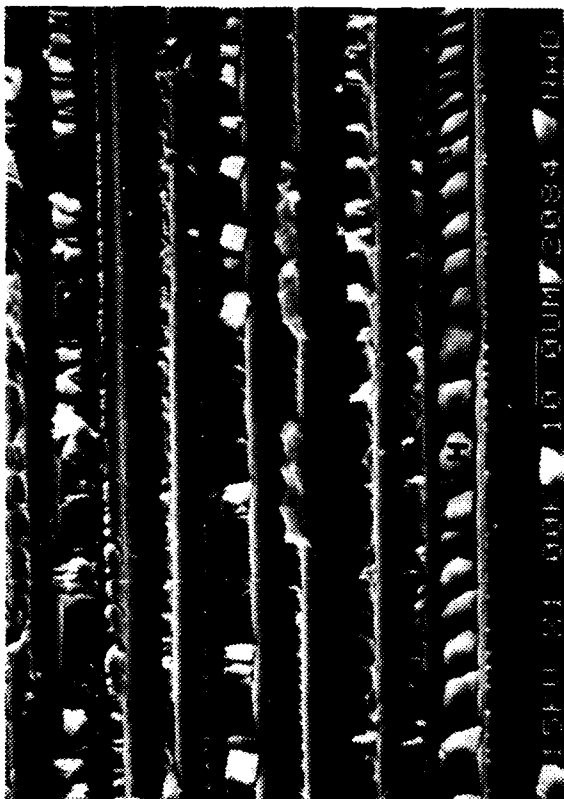
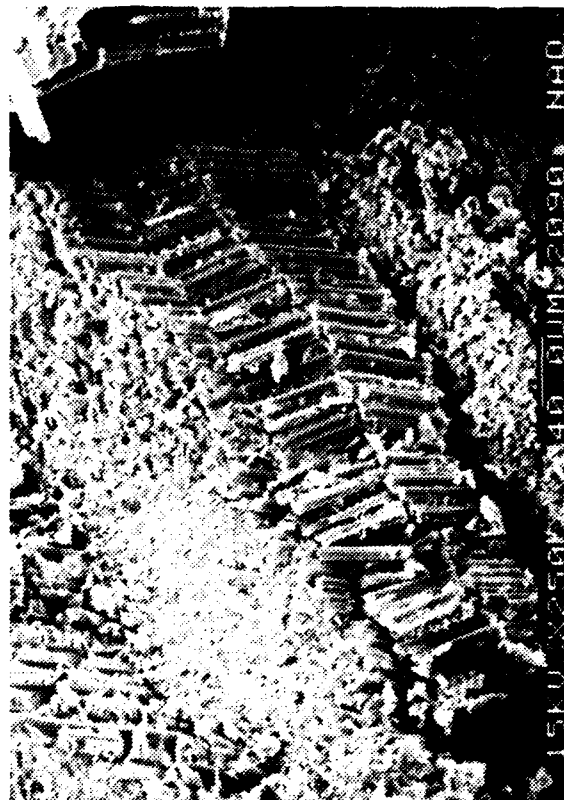
Figure 3-27. (Continued)

(d) Flexural Fracture Features

Note chop marks (C) on individual fiber ends typical of flexural fracture in compression

(f) Multiple Fiber Breaks Due to Microbuckling

Hackles and scallops were observed in the fractured epoxy in plies oriented parallel to the crack-propagation direction (Figure 3-27e). Multiple fiber breaks were also observed in all the plies, as illustrated in Figure 3-27f, and this is typical of failure due to compression microbuckling.

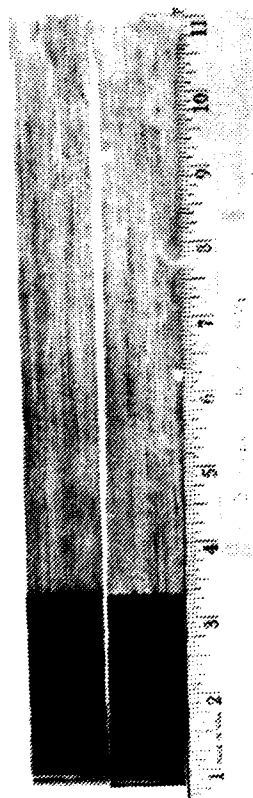
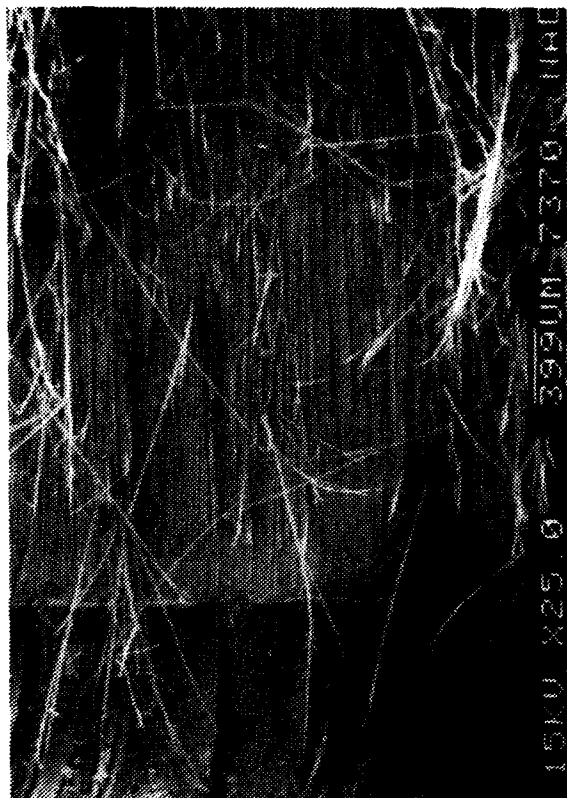
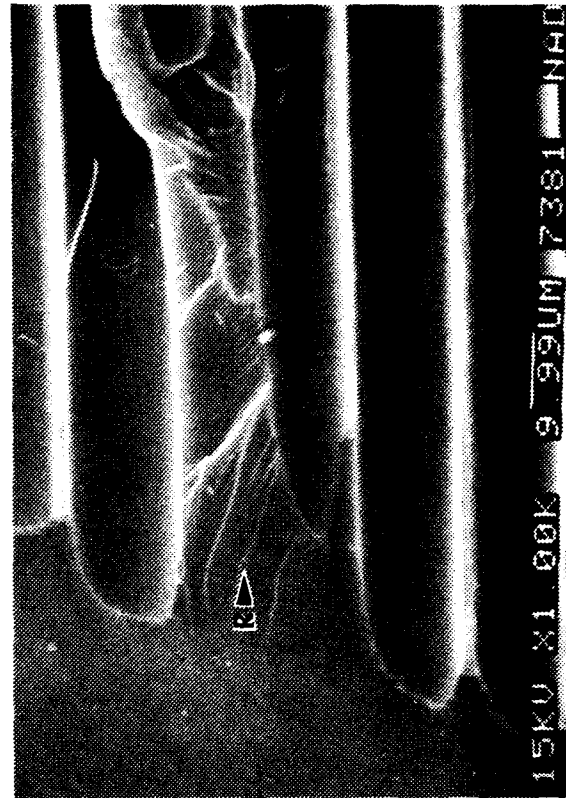
Figure 3-28. Optical and SEM Photographs of Mode I DCB Interlaminar Fracture in 49/3501-6 Kevlar/Ep -  $[0]_{24T}$ , Room Temperature Ambient

(c) River Patterns (R) in Fractured Resin

**Interlaminar Fractography.** Figures 3-28 and 3-29 present photographs for the 24/0 and 24/0,  $\pm 45$  baseline K/Ep specimens tested to failure under Mode I interlaminar tension. On a macroscopic scale, the precrack, crack-growth, and laboratory overload areas could not be distinguished as in baseline Gr/Ep. Interlaminar fracture was characterized by fibers being "pulled out" from the matrix (Figure 3-28b). In the 24/0,  $\pm 45$  variant fracture initiated at a 0/45 interface and "skipped" from one ply to the adjacent ply.

SEM examination revealed that fracture could be mapped by stray river patterns present in resin-rich areas (Figures 3-28c, and 3-29b). Fractured resin associated with pulled fibers exhibited occasional hackles (Figure 3-29c) indicating that locally the applied loads were mixed (tension and shear) in nature.

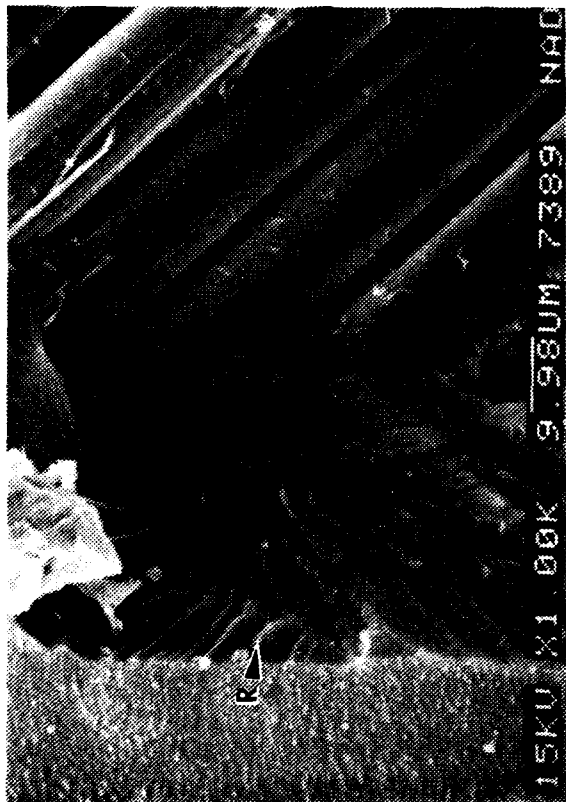
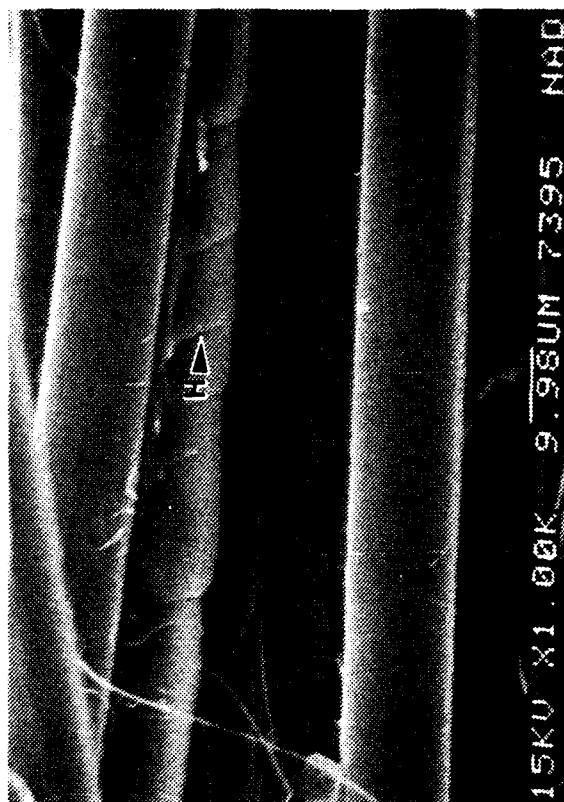
Figure 3-29. Optical and SEM Photographs of Mode I DCB Interlaminar Fracture in 49/3501-6 Kevlar/Ep - [+45/0/-45]<sub>s</sub>, Room Temperature Ambient  
 (a) Macro photograph  
 (b) River Patterns (R) at Initiation Site  
 (c) Hackles (H) in Fractured Resin

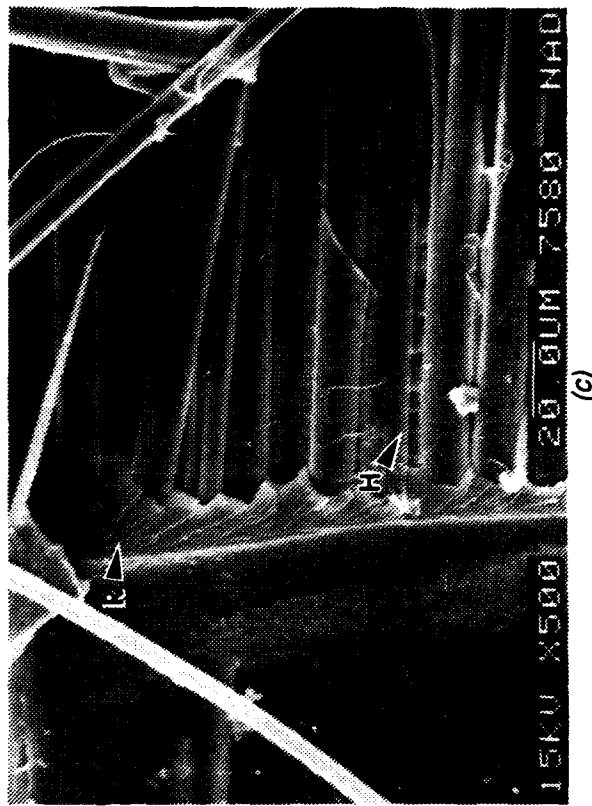
Figure 3-30. Optical and SEM Photographs of Mode I DCB Interlaminar Fracture in 49/3501-6 Kevlar/Ep -  $[0]_{24T}$ , Conditioned 180 Degrees F, Dry, 2 Weeks Before Test  
 (a) Macro photograph  
 (b) Fiber Pull-Out  
 (c) River (R) and Hackles (H) in Pre-Crack Region  
 CD = Crack-propagation direction

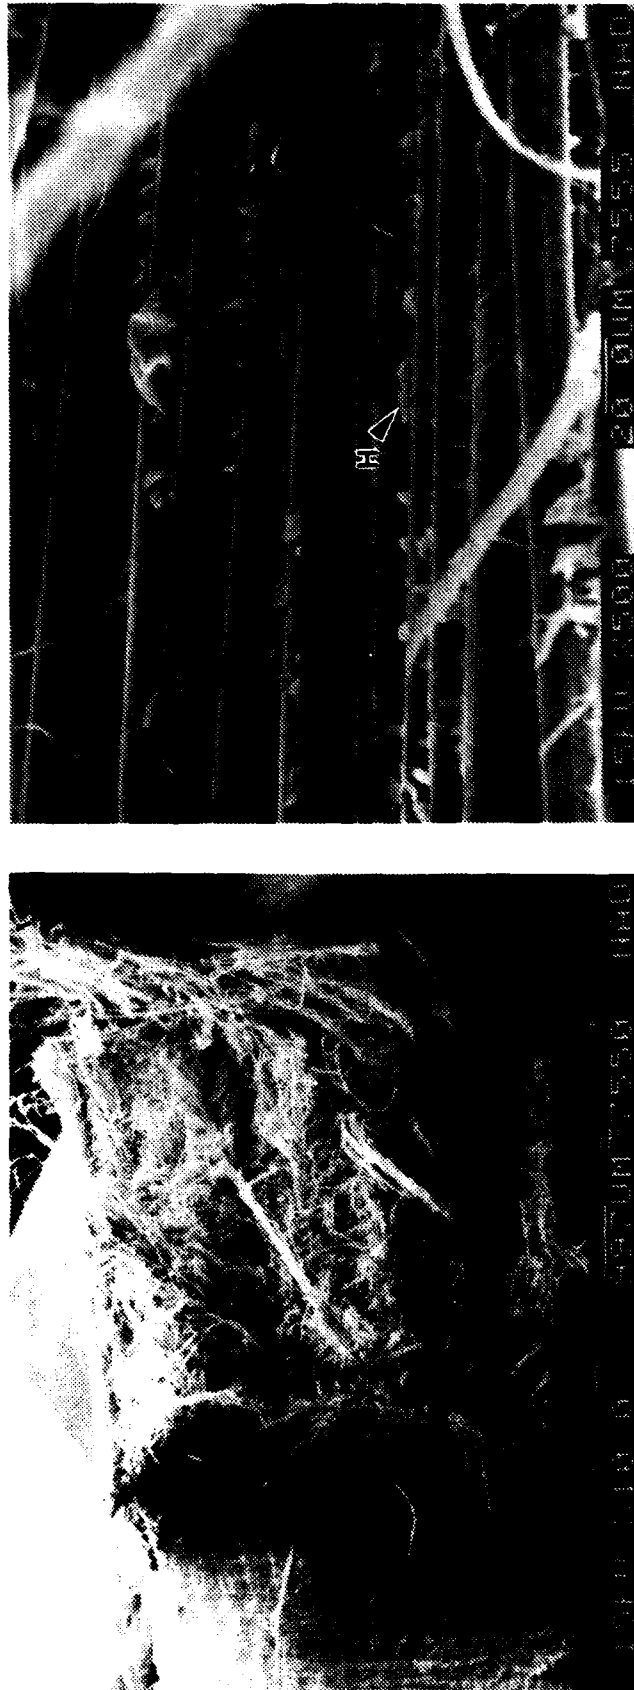
Figure 3-31. SEM Photographs of Mode I Translaminar Tension Fracture in 49/3501-6 Kevlar/Ep - [90/0]<sub>8s</sub>, Room Temperature Ambient

- (a) Dense Tangles of Fibrils
- (b) Hackles (H)

CD = Crack-propagation direction

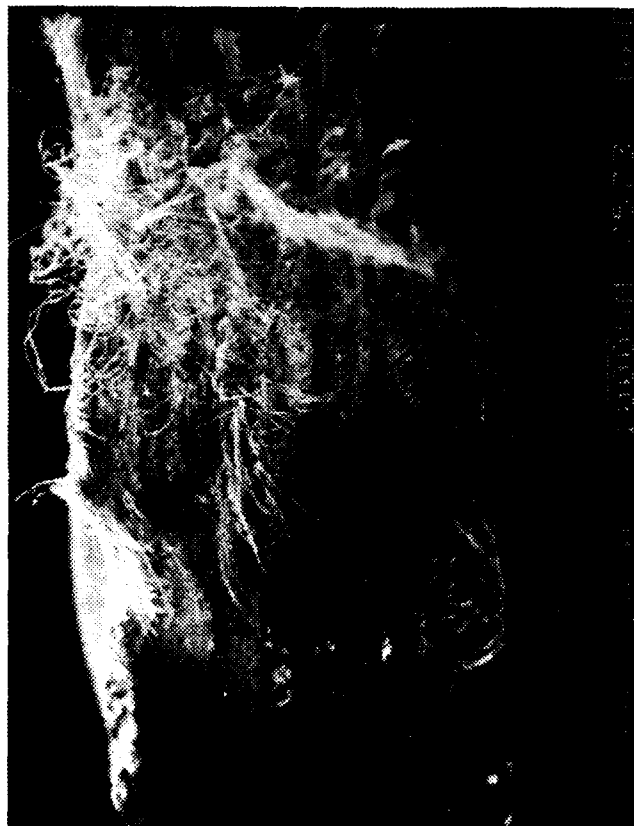
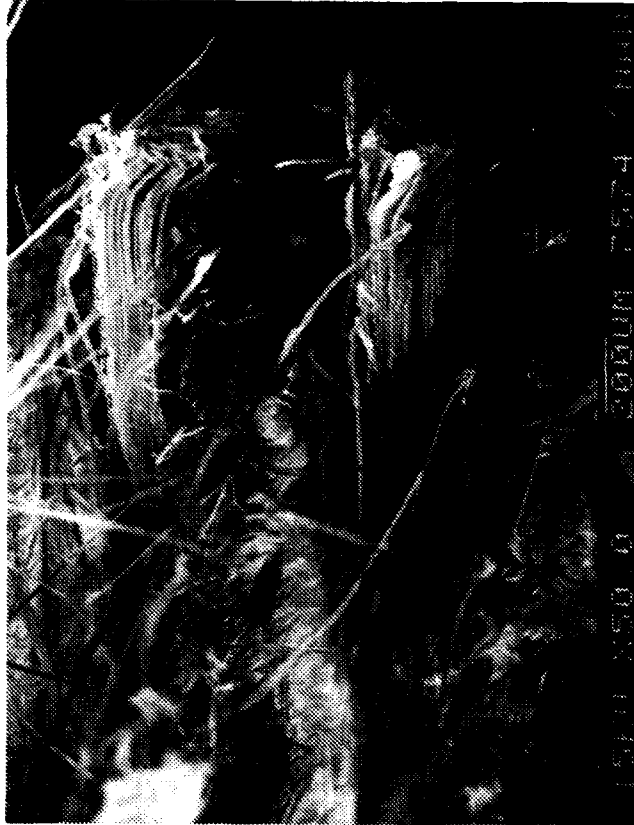
Figure 3-32. SEM Photographs of Mode I Translaminar Tension Fracture in 49/3501-6 Kevlar/Ep - [90/0]<sub>BS</sub>, Conditioned 180 Degrees F, Dry, 2 Weeks Before Test

CD - Crack-propagation direction

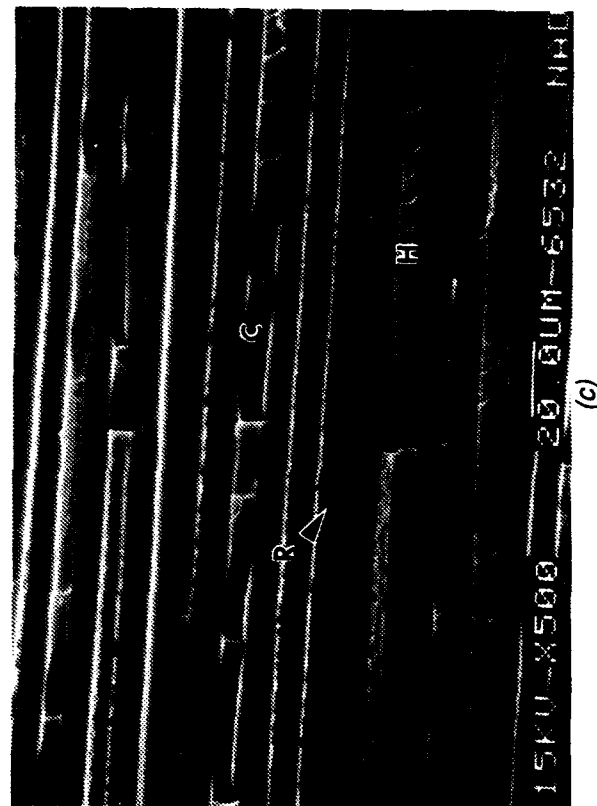
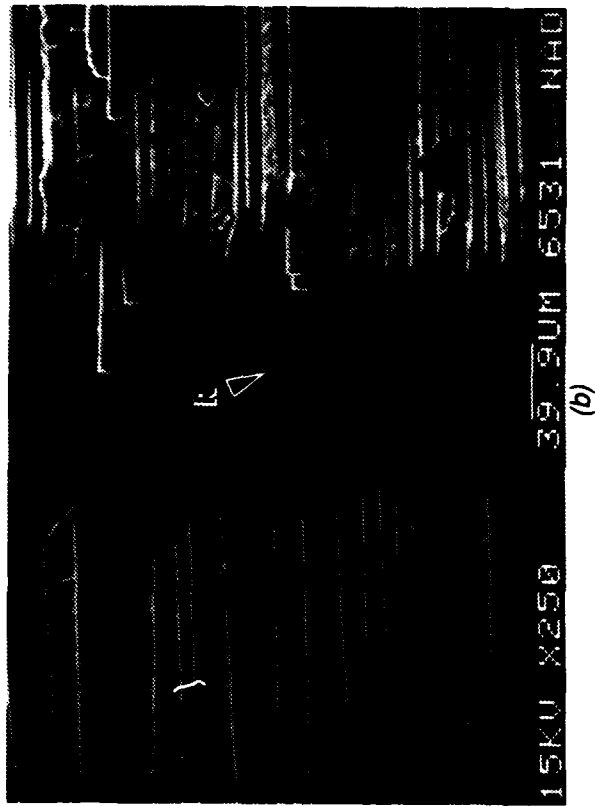
Figure 3-33. Optical and SEM Photographs of Mode I and II MMF Interlaminar Fracture in AS4/5250-3 Gr/BMI - [0]<sub>24T</sub>, Room Temperature Ambient  
(a) Macrograph of Regions I, II, III (Pre-crack, Crack-Growth, and Laboratory Overload Fracture Areas)  
(b) River Patterns (R) in Initiation Region in Pre-crack  
(c) Rivers (R), Hackles (H), and Cusps (C) in Crack-Growth Region

CD = Crack propagation direction

**Interlaminar Fractography.** Figure 3-33 presents fracture features in unidirectional Gr/BMI tested to failure under mixed Mode I tension and Mode II shear interlaminar loads. The fracture could be categorized on a macroscopic level into three regions as for baseline Gr/Ep (Figure 3-33a). Fracture initiated at resin rich regions adjacent to the Armalon film, and could be mapped by the river patterns in the fractured BMI resin. Peel fracture in Region II was characterized by a mixture of hackles, cusps, and river patterns, with the rivers being oriented at an angle to the crack-growth direction (Figure 3-33c).

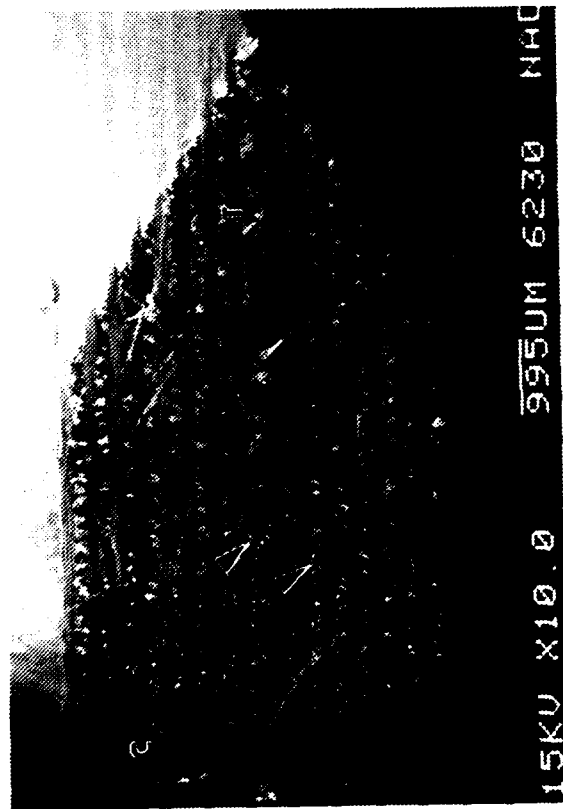
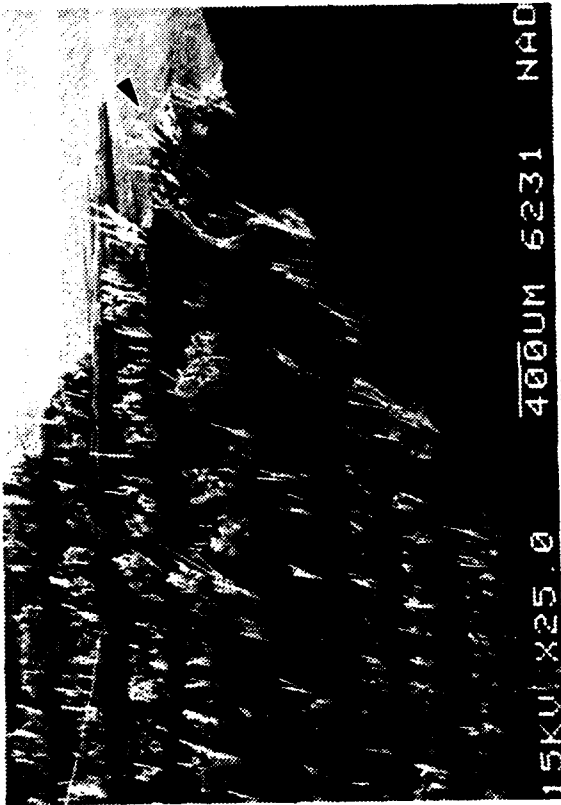
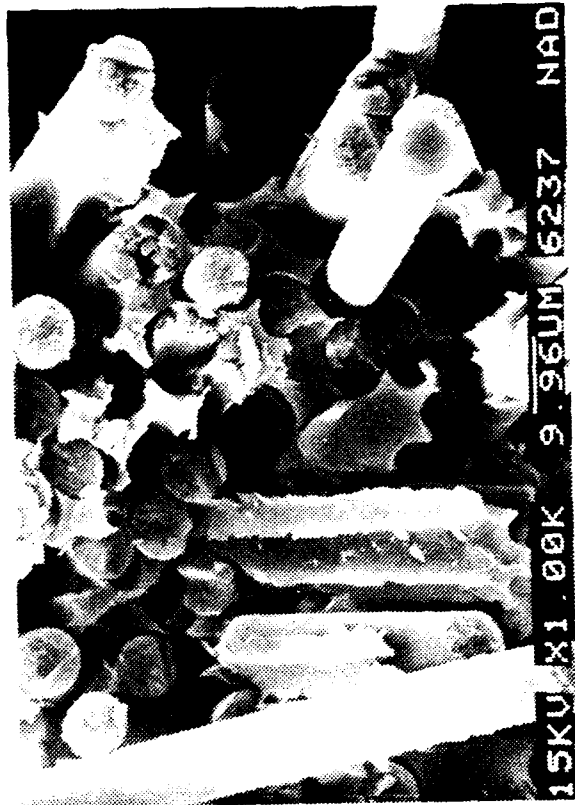
Figure 3-34. SEM Photographs of Mode I Translaminar Tension Fracture in AS4/5250-3 Gr/BMI - [90/0]<sub>as</sub>

(a) Normal Views of Fracture

(b) Oblique View of Fracture

(c) Fiber Pull-Out and Separation From Resin in Tension Region of Fracture

CD = Crack-propagation direction

T = Tension region

**Translaminar Fractography.** Figure 3-34 provides photographs of fracture in AS4/5250-3 Gr/BMI tested under translaminar tension. Fractured zero degree fibers in the tensile regions resembled coarse chevrons oriented toward the fracture origin (Figure 3-34a). These features were similar to those reported by David Purslow for 90/0 translaminar fractures in Gr/Ep (Reference 8). These served as indicators of the fracture origins in a manner similar to chevrons in metallic materials.

Unlike Gr/Ep, translaminar failure in Gr/BMI was characterized by extensive fiber pull-out, with local fiber bundles in the tensile regions exhibiting bending caused by flexural loads (Figure 3-34b).

Figures 3-34c and 3-34d show microscopic fracture characteristics in the tensile regions. Unlike Gr/Ep, fracture in local plies oriented normal to the applied load exhibited extensive pull-out and ductile separation of fibers from the adjoining resin (Figure 3-34c). In addition, fractured fibers in the tensile regions exhibited a mix of DAF radials (indicative of tension failure), and chop marks (indicative of compression failure), as shown in Figure 3-34d. The compression characteristics are believed to be caused by localized flexural loading of fiber bundles in the tensile regions.

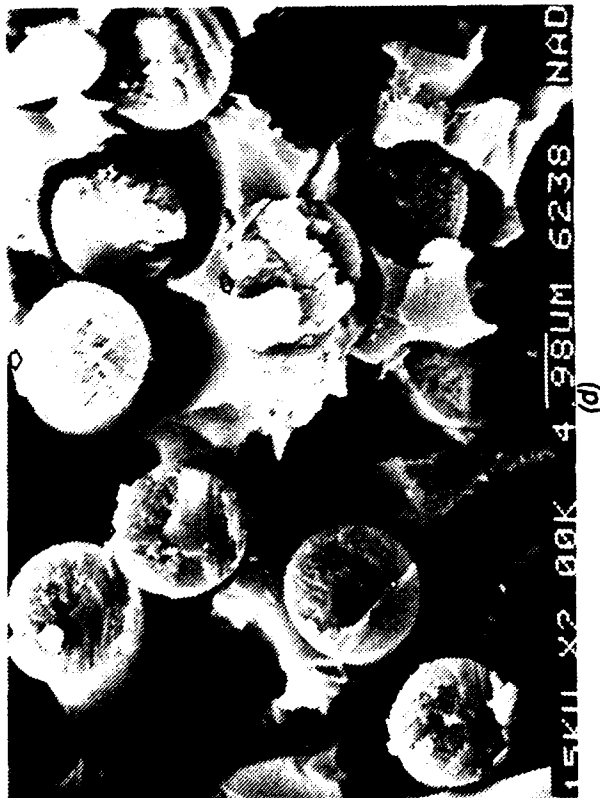
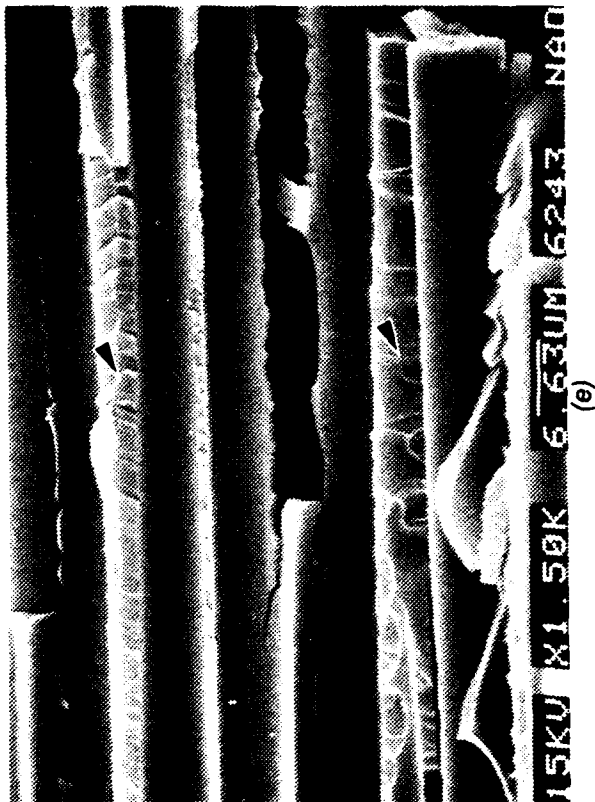
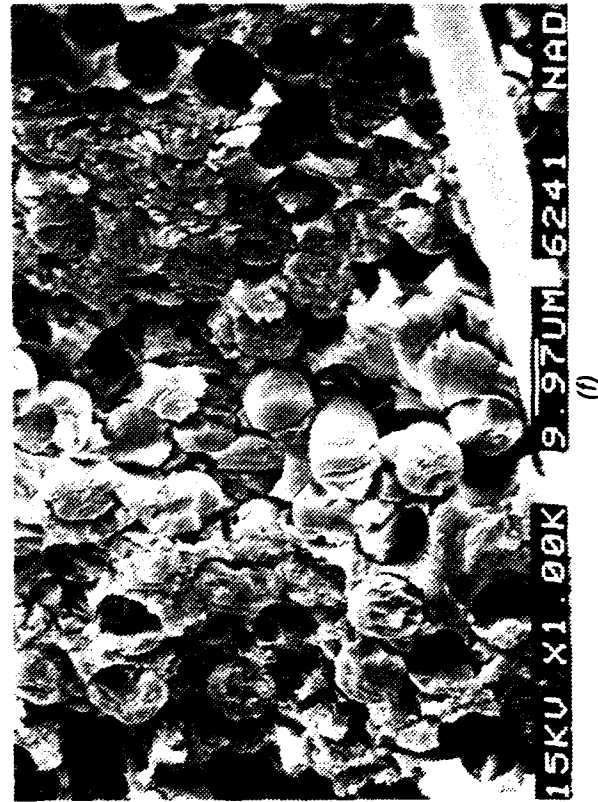
Figure 3-34. (Continued)  
 (d) Chop Marks (Solid Arrows) and DAF Radials  
 (Hollow Arrows) on Fiber Ends  
 (e) Resin Fracture in 90 Degree Ply (Tension)  
 Note river patterns (arrows)  
 (f) Chop Marks on Fiber Ends in Compression  
 Region

CD = Crack propagation direction

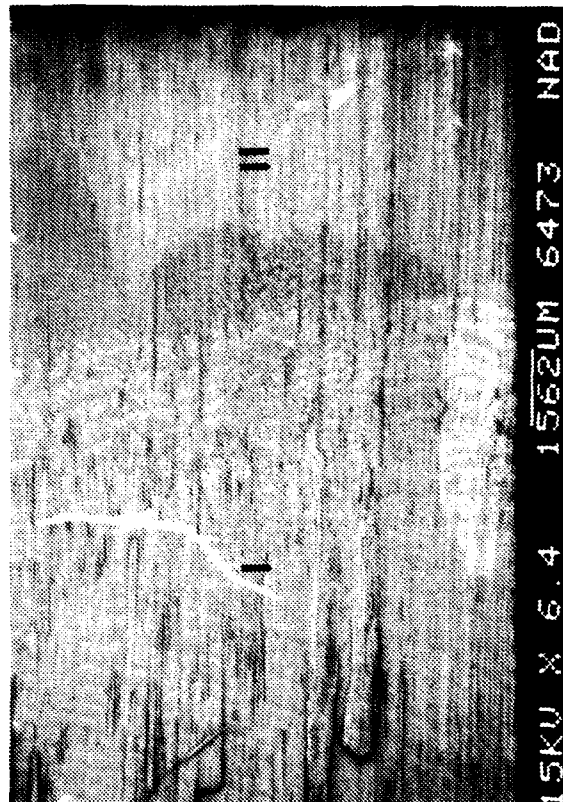
Figure 3-35. Optical and SEM Photographs of Mode II ENF Interlaminar Fracture in AS4/APC-2 Gr/PEEK - [0]<sub>24T</sub>, Room Temperature Ambient

Note absence of ribs in region II

CD = Crack-propagation direction

**Interlaminar Fractography.** Figure 3-35a shows a macrophotograph of fracture in a unidirectional AS4/APC-2 ENF specimen tested to failure. On a macroscopic scale, the fracture could be categorized into Regions I, II and III. Regions I and III were areas of peel fracture. Region II was the shear fracture.

Figures 3-35b and 3-35c are low magnification photographs of the fracture. Regions I and III were characterized by ribs (Figure 3-35b) that were concentric about the initiation area. In contrast, Region II was devoid of ribs (Figure 3-35c). These observations confirm Purslow's findings that ribs did not form in pure shear.

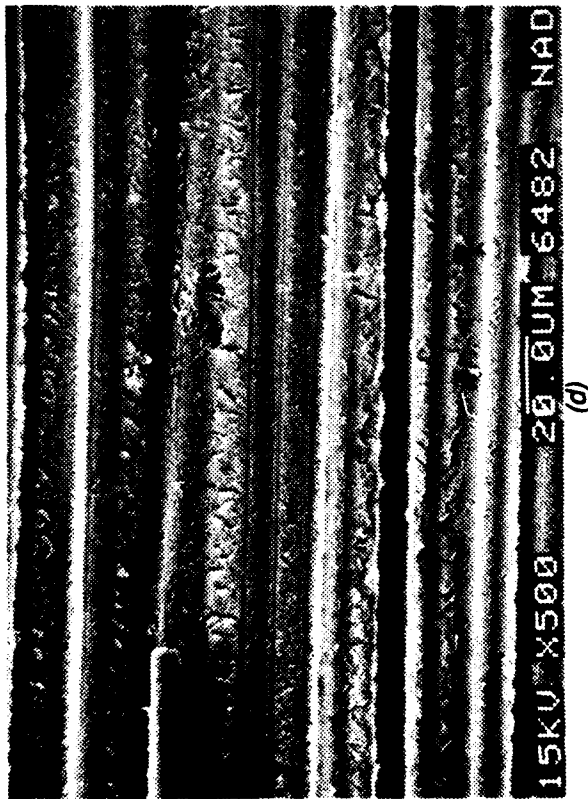
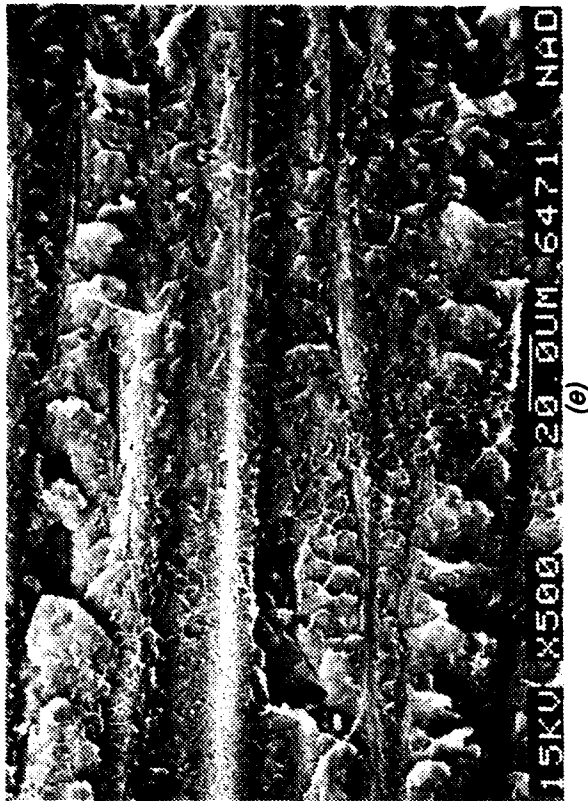
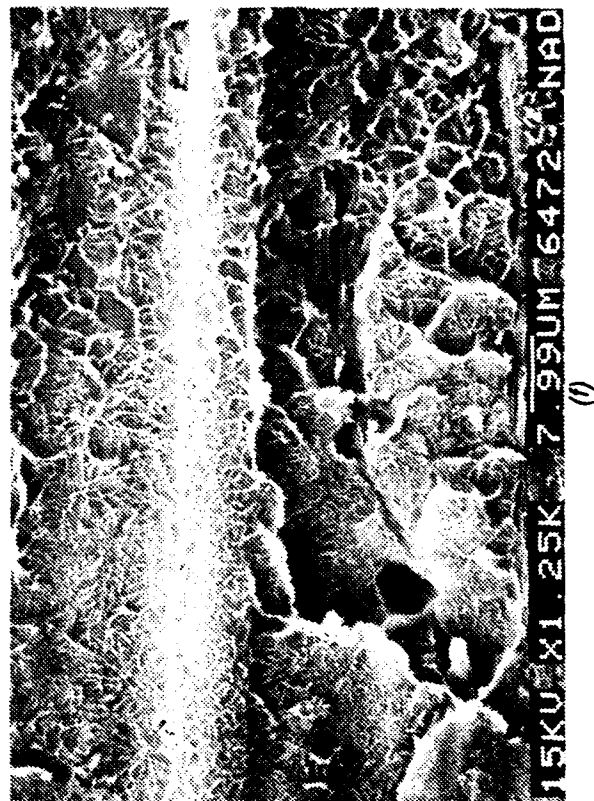
Figure 3-35. (Continued)  
 (d), (e) Region I Fracture  
 (f) Peel Fracture in Region I  
 CD = Crack-propagation direction

Figures 3-35d, 3-35e and 3-35f present high magnification SEM photographs of fracture in Region I. This precrack region did not exhibit indicators of crack-growth direction; however, examination of mating halves of the fracture in Region II (interlaminar shear region) revealed the occurrence of drawn fibrils that were oriented toward the crack-growth direction in one half, and away from the crack-growth direction in the mating half (Figure 3-35g and 3-35h).

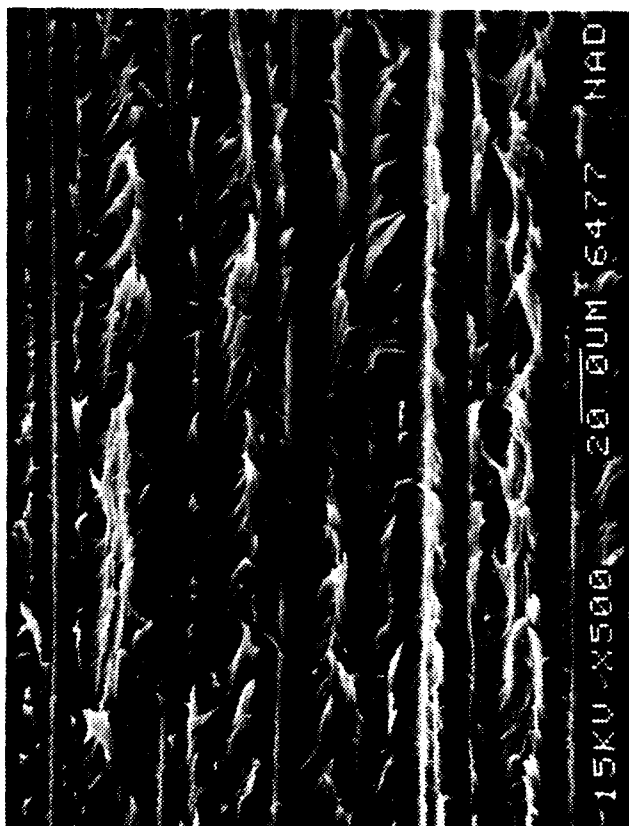
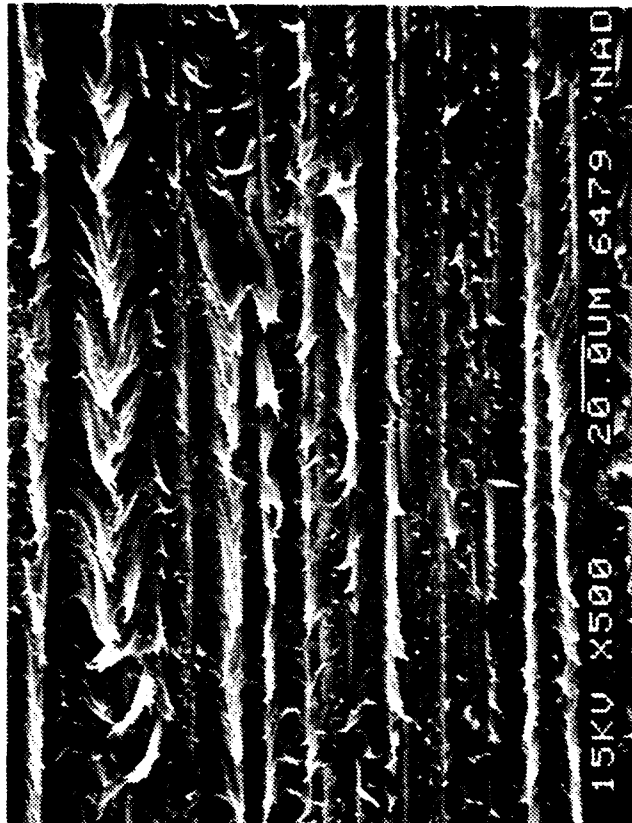
Figure 3-35. (Continued)  
 (g), (h) Shear Fracture Regions in Mating Fracture Halves  
 Note orientation of drawn fibrils (arrows) in relation to CD

CD = Crack-propagation direction

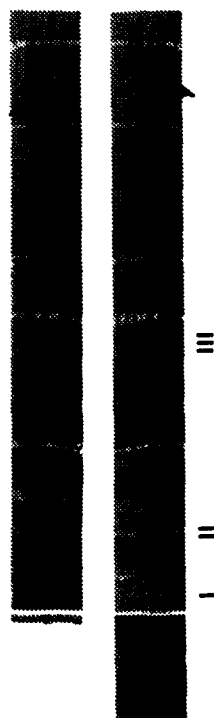
Figure 3-36. Optical and SEM Photographs of Mode I and Mode II MMF Interlaminar Fracture in AS4/APC-2 Gr/PEEK - [0]<sub>24T</sub>, Room Temperature Ambient  
 (a) Macro photograph  
 Note: I, II, III are pre-crack, crack-growth, and laboratory overload regions and arrows indicate ribs in region III.  
 (b) Ribs in Region II

CD = Crack propagation direction

Figure 3-36 presents fracture features in unidirectional Gr/PEEK tested to failure under mixed Mode I tension and Mode II shear interlaminar loads. The fracture could be categorized on a macroscopic level into three regions as before (Figure 3-36a). Examination at low magnifications (Figure 3-36b) revealed the presence of rib formation all over the fracture that could be used to map crack-propagation direction, since these were oriented radially outward and emanating from the initiation regions. The presence of ribs all over the fracture surface would be expected since the precrack, crack-growth and laboratory overload fracture regions (Regions I, II, and III, respectively), had all formed under peel loads.

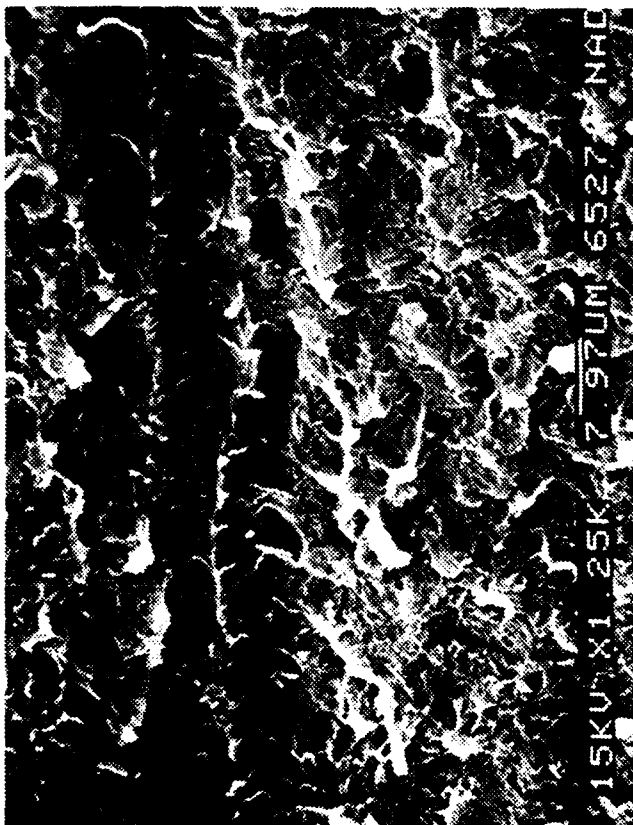
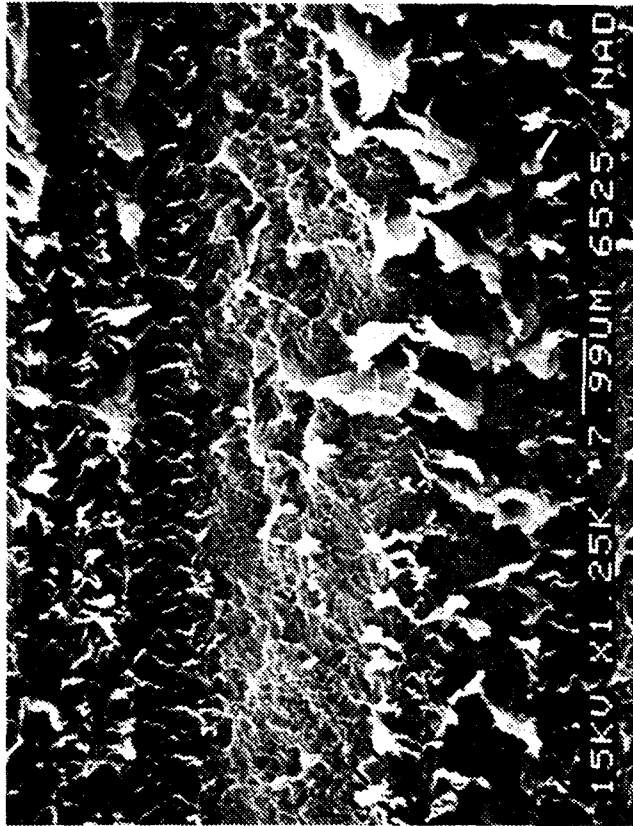
Figure 3-36. (Continued)  
 (c), (d) Shear Fracture Region in Mating Fracture Halves  
 Note orientation of drawn fibrils (arrows) in relation to CD

CD = Crack-propagation direction

SEM examination of the microscopic fracture features in mating fracture halves (Figures 3-36c and 3-36d) revealed drawn fibrils that were oriented either away from the crack-growth direction or toward the crack-growth direction in both halves. Pure shear fracture was characterized by fibrils drawn toward the crack-growth direction in one half, and away from the crack-growth direction in the mating half. It was determined that the drawn fibrils could not be used to establish crack-growth direction in mixed mode fractures; however, examination of these features on mating halves permitted identification of peel failure regions from regions of shear.
